***Phase 1 Data Review of Hydrologic and Geomorphic
Conditions in the Upper Tryon Creek Watershed,
1997***

Prepared for:
West Multnomah Soil and Water Conservation District
Portland, OR

Prepared by:
Philip Williams & Associates, Ltd.
Kevin G. Coulton, P.E.
Troutdale, Oregon 97060
December 19, 1997

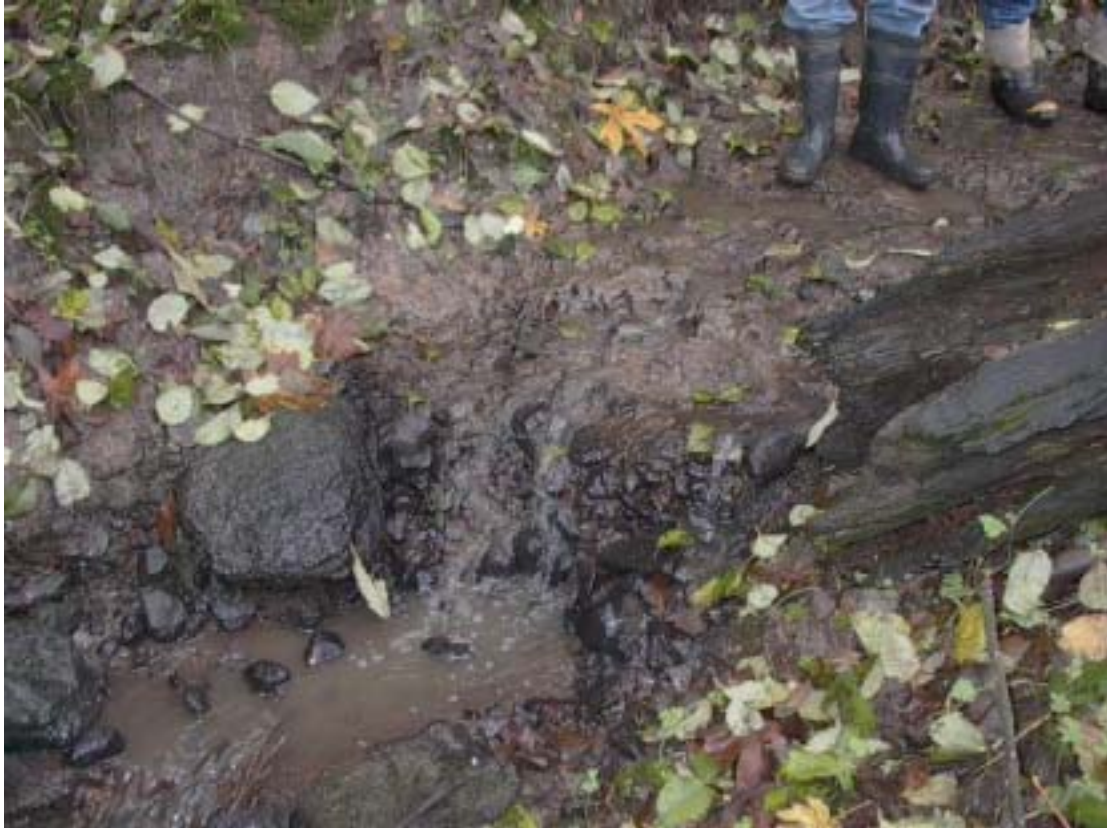
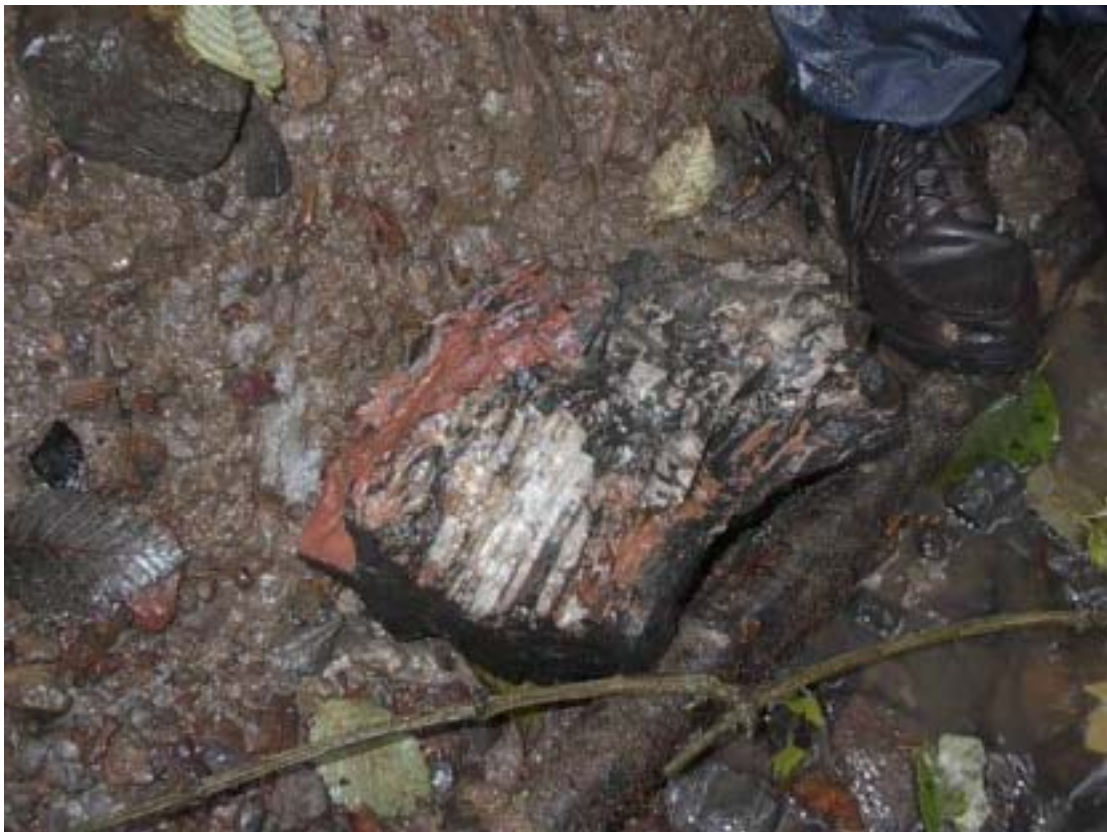
Photo: Erosion exposes boulders in stream bank in lower state park.

The creek channels in the UTC watershed are generally characterized in the BES corridor assessment as incised (downcut) with varying degrees of bank erosion. This is a geomorphic process typical of headwater streams where steep channels provide high amounts of gravitational energy to flowing water to erode channel bed and banks. Incised channels gradually widen by scouring and flattening bank slopes to achieve a more stable condition (Figure 3). Depth to bedrock is typically shallow in the UTC watershed and in locations where creek channels have scoured down to bedrock, the only adjustment the channel can make is to erode laterally. Historic and current human interventions in the watershed have changed the natural patterns of runoff to the creek channels and have likely changed the natural stability and evolution of the creek channels.

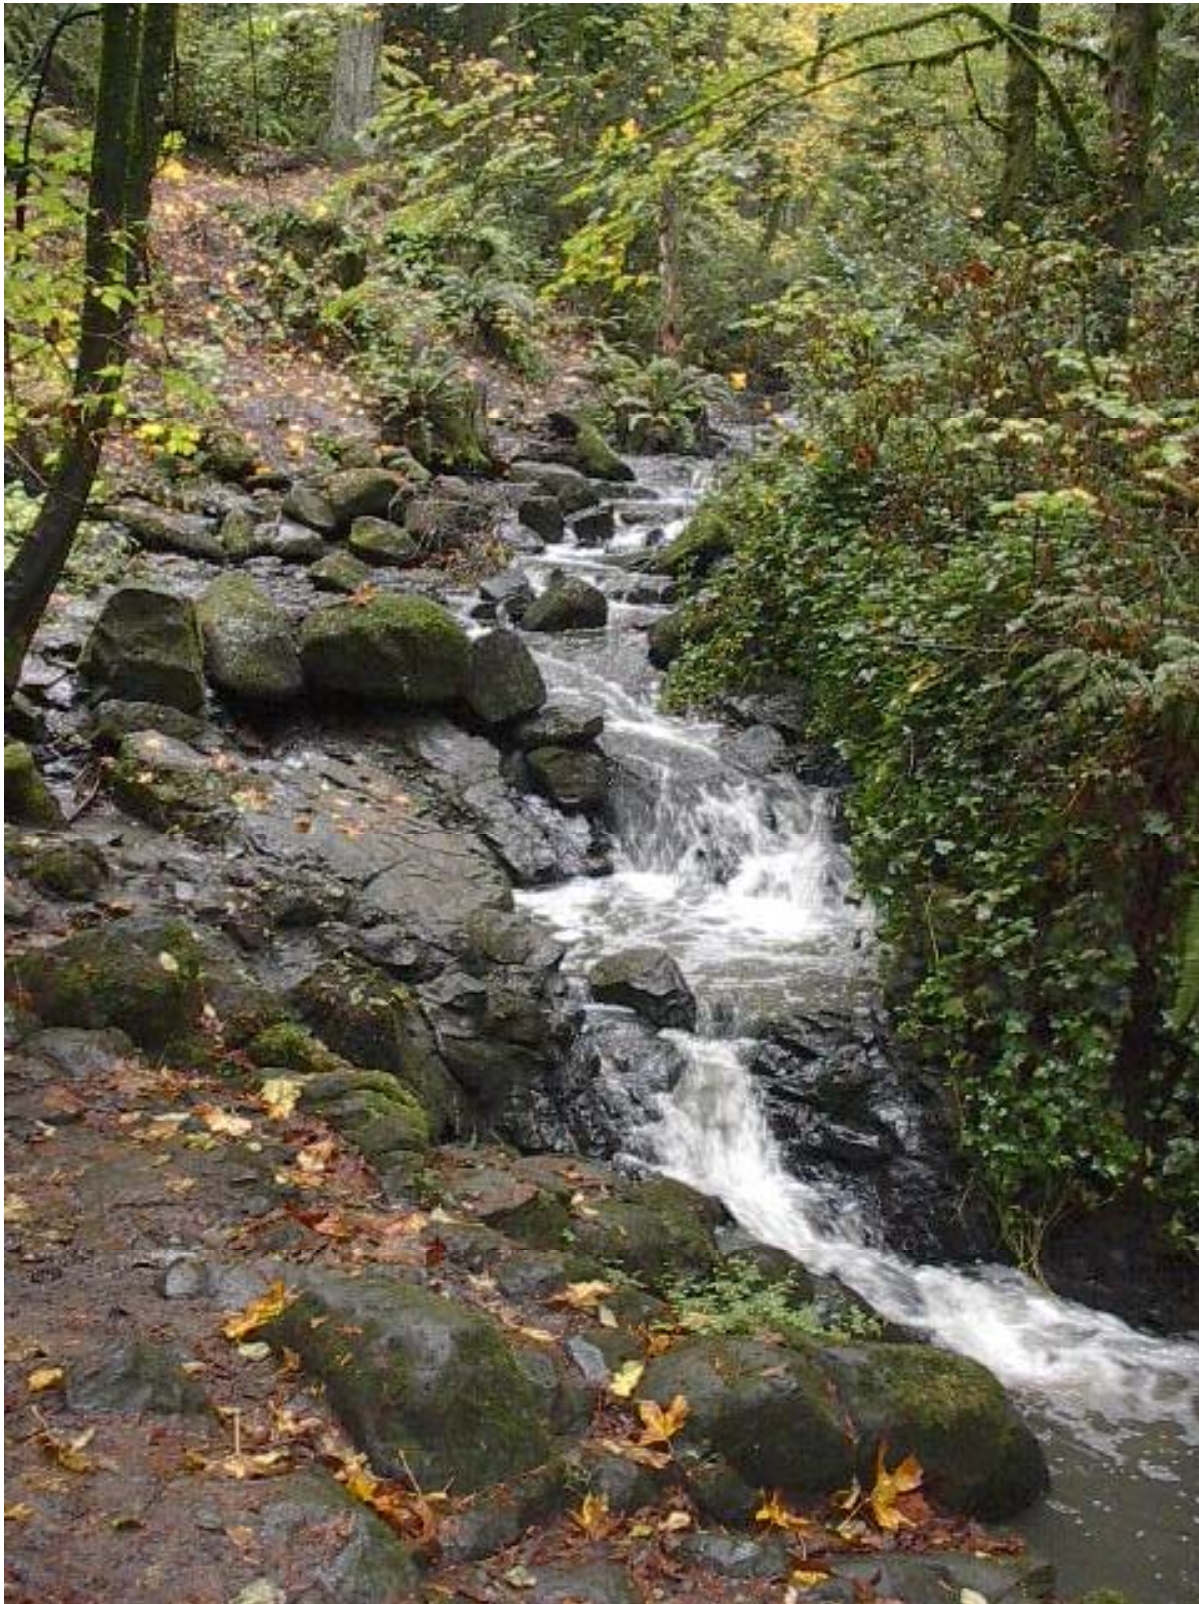
Small creek cascades down boulders. English ivy overruns the north bank. Location: Marshall Park, west tributary.
