***Tryon Creek Environmental Baseline Conditions and
Limiting Factors Analysis For Anadromous Salmonids***

Prepared for:
West Multnomah Soil and Water Conservation District
2115 SE Morrison Street, Room 104
Portland, OR 97214

Prepared by:
Bernard Klatte, Fisheries Biologist &
Robert Ellis, Ph.D., Fisheries Biologist
Ellis Ecological Services, Inc.
4 January 2002

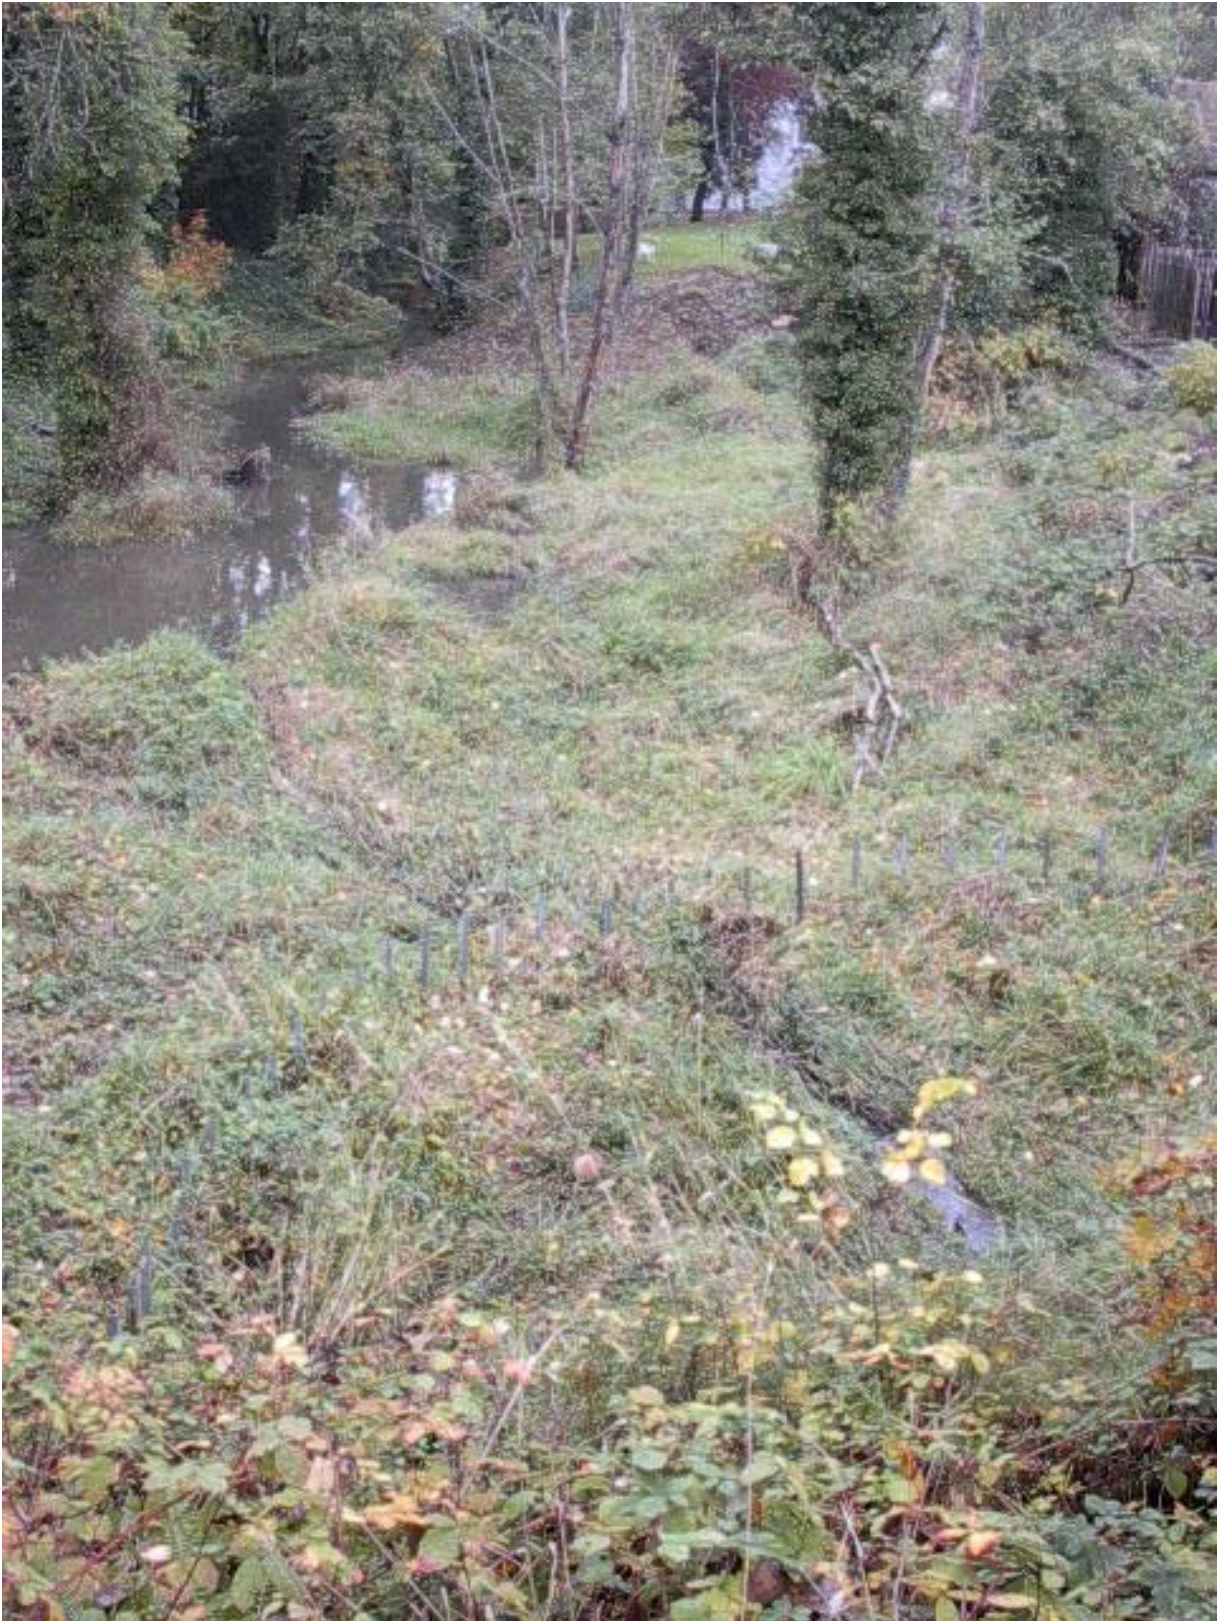
Outer watershed: open land behind an apartment building at SW 26th and Dolph Court. Portland BES tree- planting project. Date of this photo was November 31, 2001. See following page for same general area in July, 2003

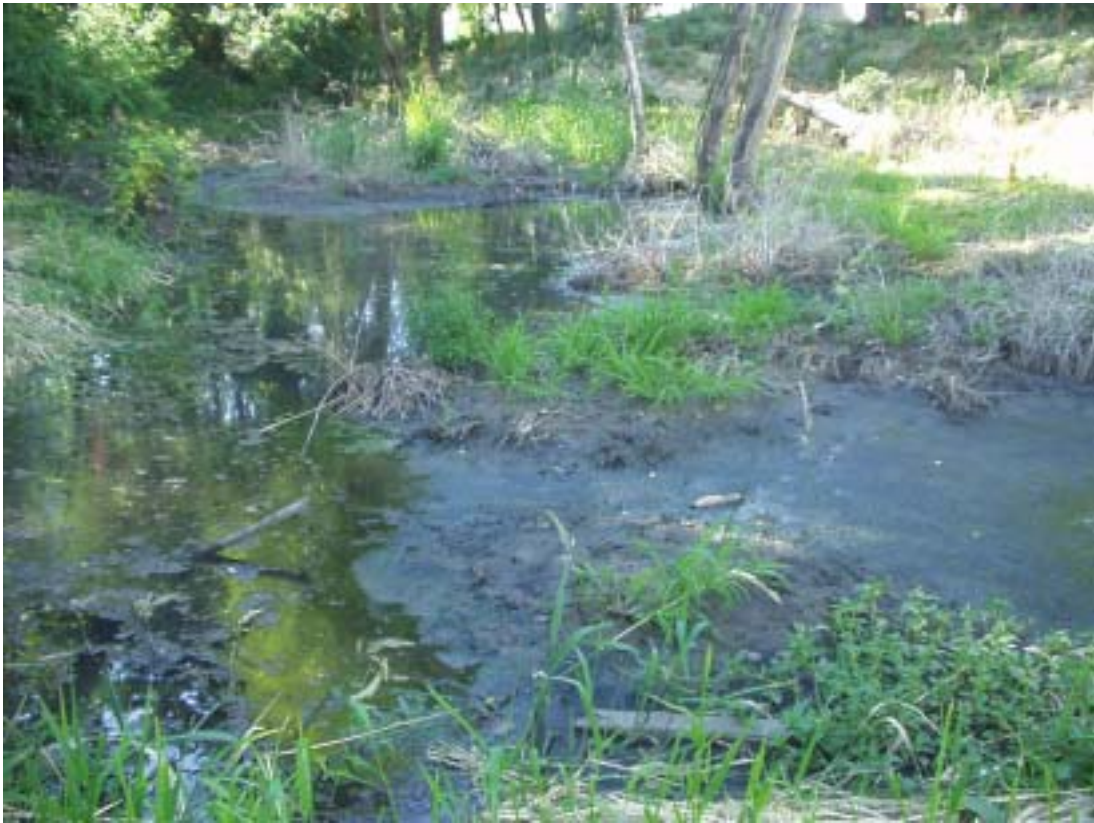
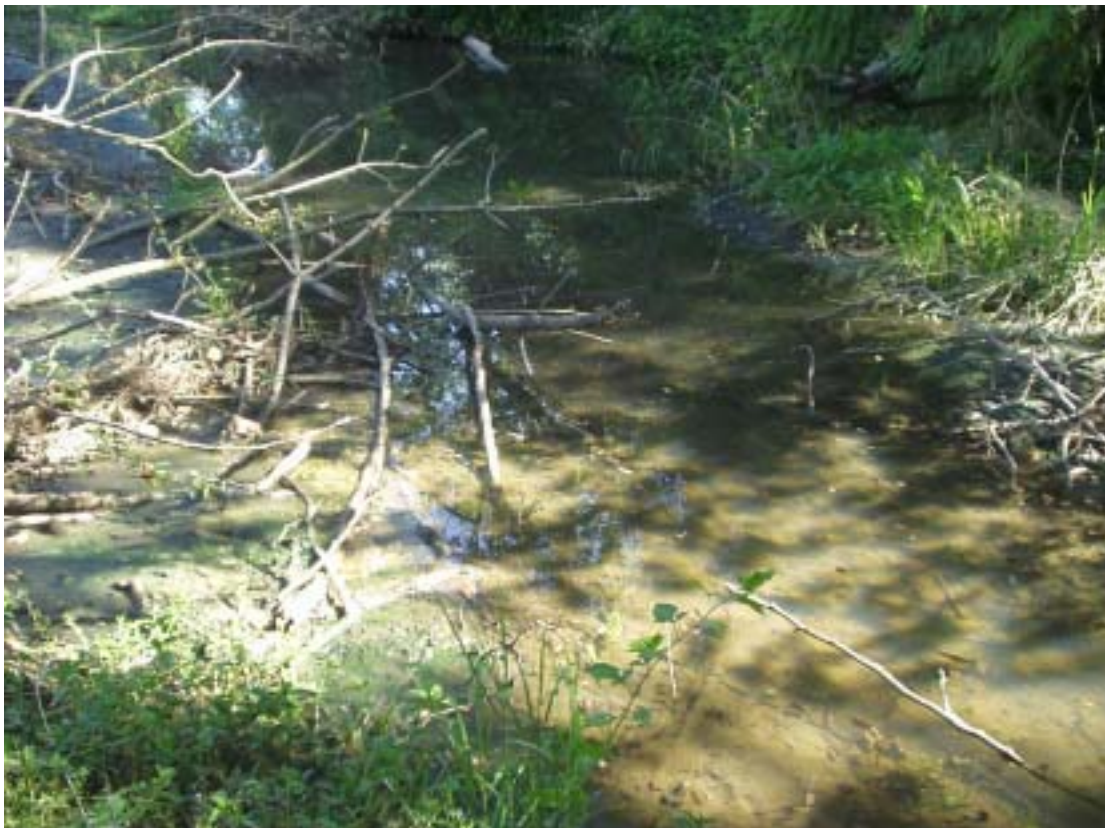
Same site as preceding page, in July, 2003. Creek now appears as a series of backed up, stagnant ponds which drain into a culvert under the adjacent street (SW Dolph Court). Creek later has to pass under Interstate 5.
